Atmospheric degradation of zinc-nickel alloy electrodeposited coatings

*Katerina Kreislova, Alena Koukalova, Libor Turek, SVÚOM Ltd.,
Prague/Czech Republic*

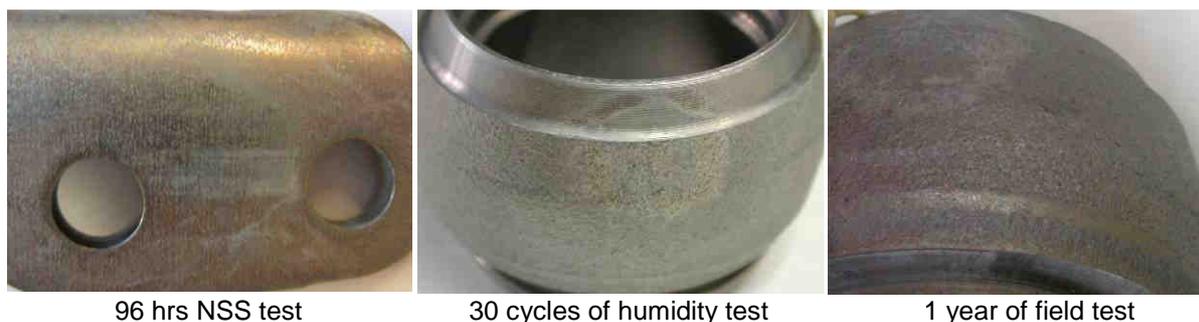
Figure 1: White-grey veil formed in different corrosion conditions

The corrosion mechanism of Zn–Ni alloy coating differs from traditional zinc coating. Several corrosion mechanisms for electrodeposited zinc-nickel coating have been suggested [1] - 5]. The Zn-Ni coatings have a tendency to quickly production of white corrosion which is different to zinc corrosion products. In the first stage of corrosion attack of Zn–Ni alloy coating in all basic corrosion conditions the effect of „white-grey veil“ occurs. This very thin layer is different from the typical white corrosion products of zinc coating (Fig. 1).

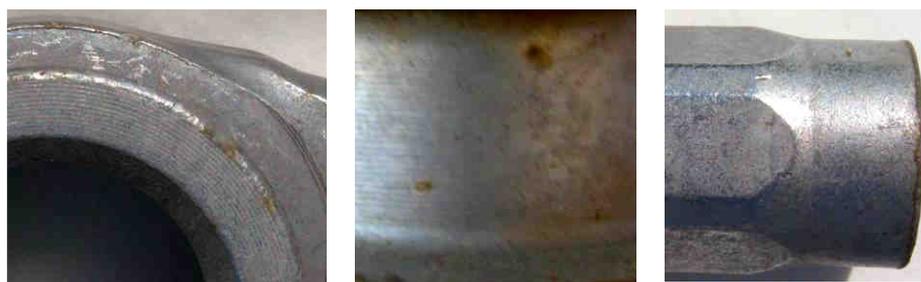
Figure 2: The corrosion of substrate steel after 3 months exposure on atmospheric test site

Other specific corrosion phenomenon is the localized corrosion of substrate steel without significant corrosion of Zn-Ni coating but with possible pitting corrosion of this coating. The reasons of the pitting corrosion of Zn-Ni coating are probably different in respect to exposure conditions – penetration of corrosion stimulators through cracks and/or de-alloying of Zn-Ni coating. The first manifestation of corrosion of substrate steel had been found after 20 cycles (480 hrs) of humidity test and after 3 months of atmospheric test at locality without salinity deposition (Fig. 2). The diameter of pits was in range from 0.1 to ca 5 mm.

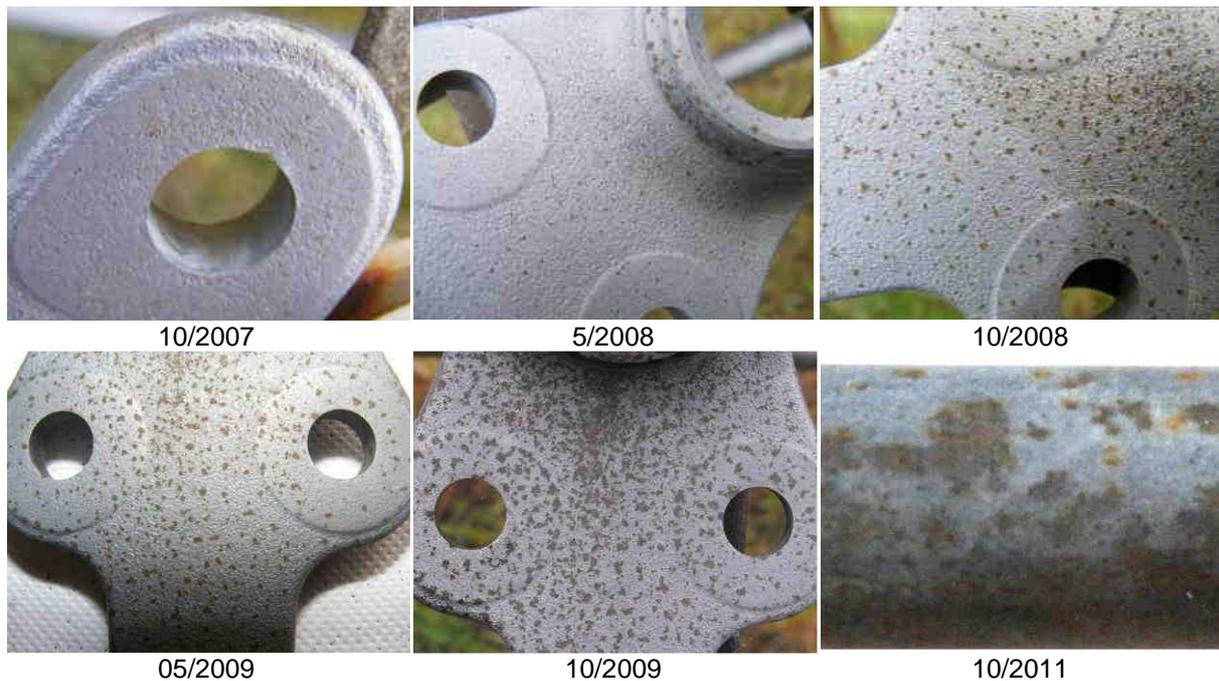
**Figure 3:** Progress of corrosion attack of Zn-Ni coating exposed at test sites Kopisty

The atmospheric corrosion had been evaluated on the automotive compounds with Zn-Ni coating and various types of additional surface treatments (see Table 1) – Fig. 3. The detailed study had been performed for samples exposed for 1 and 5 years.

With the time of exposure the corrosion attack of Zn-Ni coating in the form of stains of corrosion product of substrate steel increased without any significant occurrence of corrosion product of zinc (Fig. 3). The corrosion attack formed as pits with the depth ca 40 µm after relative short exposure and this depth left the steady during the following exposure only the diameter of pits increased and pits jointed together (Fig. 8).

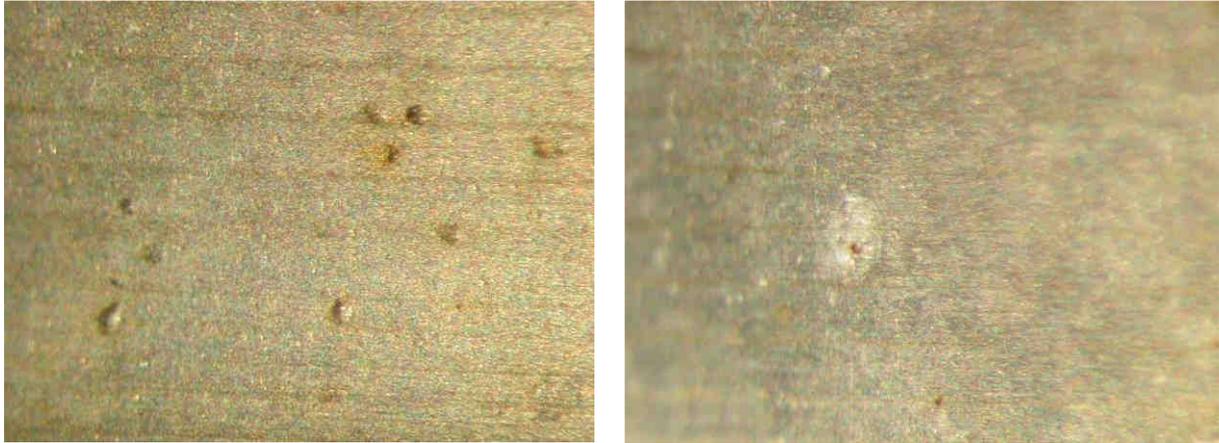
Figure 4: The details of corroded Zn-Ni coating exposed 1 year at test sites Kopisty

After one year exposures at atmospheric test site the small stains of corrosion products of substrate steel had been evident (Fig. 4). The details of corrosion attack of Zn-Ni coating layer are evident from cross section of samples. The corrosion attack of substrate steel surface under the layer of Zn-Ni coating had been found and the presence of sulphur as a dominant corrosion stimulator was proved by mapping by scanning electron microscope (Fig. 5c). The corrosion attack of substrate steel is manifested in the cracks of Zn-Ni coating.

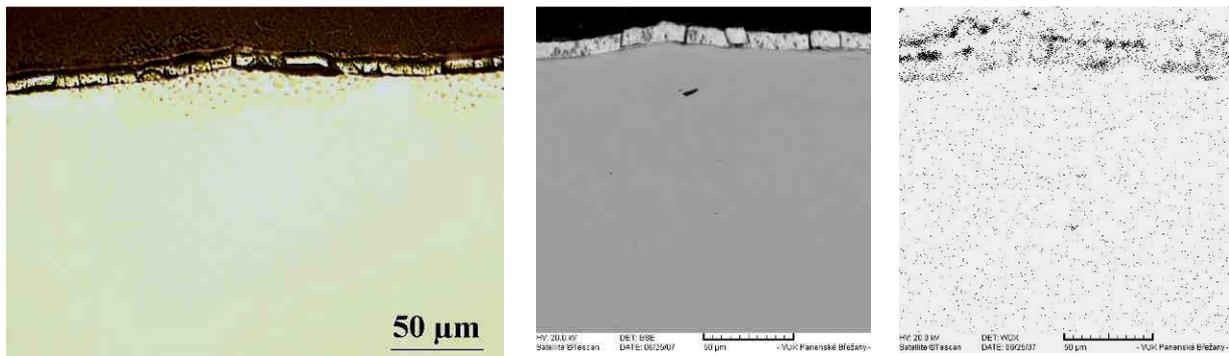
Figure 5: The cross section of corroded Zn-Ni coating exposed 1 year at test sites Kopisty in light and scanning electron microscopy and the distribution of sulphur

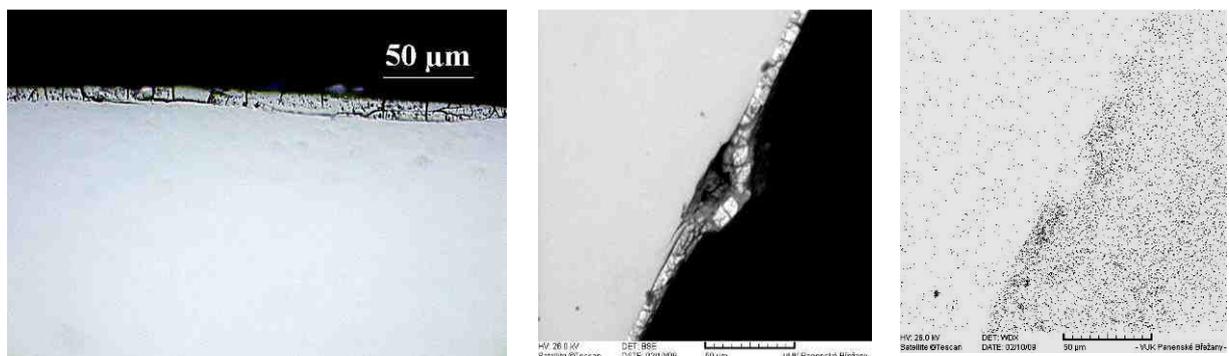
Figure 6: The cross section of corroded Zn-Ni coating exposed 5 year at test sites Kopisty in light and scanning electron microscopy and the distribution of sulphur

The detail of corroded surface after 5 years of exposure is given on Figs. 6 and 7. The cross section shows the blister of corrosion product of substrate steel which caused the lost of adhesion of electrodeposited alloy Zn-Ni coating. The distribution of elements on the exposed surface shows the lower concentration of nickel in cracks and increased concentration of sulphur as dominant corrosion stimulator in the corrosion stain of substrate steel on the coating surface.

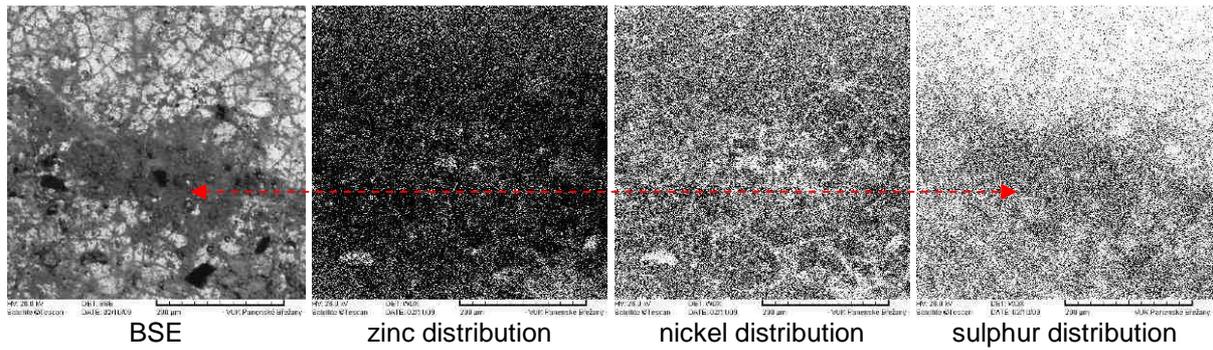
Figure 7: The surface of corroded Zn-Ni coating exposed for 5 year at test sites Kopisty in scanning electron microscopy and the distribution of Zn, Ni and S

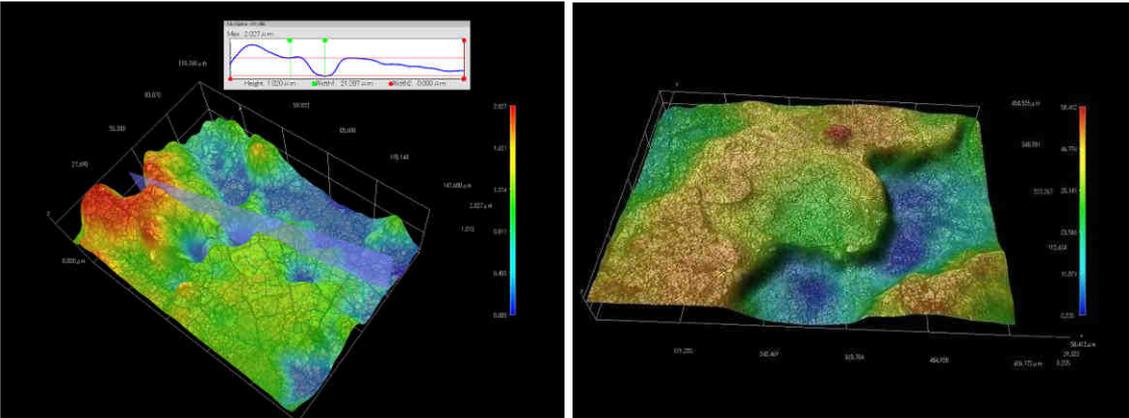
Figure 8: The profile of corroded Zn-Ni coating exposed 2 years (left) and 5 years (right) at test site Kopisty evaluated by Hirox microscope

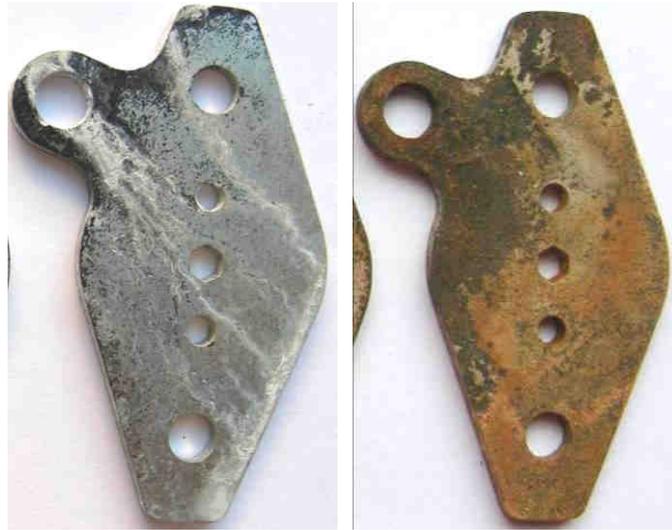
Figure 9: Component with Zn-Ni alloy coating corrosion attack after 600 hrs of NSS test (left) and 5 cycles in test with SO₂ (2 L dosage) (right)

During last 2 – 3 years the requirements of testing this coating into accelerated laboratory test - sulphur dioxide test with general condensation of moisture (Figs. 9 and 10). The corrosion products were indentified as dominant $ZnSO_3 \cdot 2.5H_2O$ and traces of $Ni(SO_3)_2 \cdot 6H_2O$ after 1 cycle of this test. The resistance of the coating in this

test is very low due to cracks in coating structure. The most reliable results give the field test of this coating.

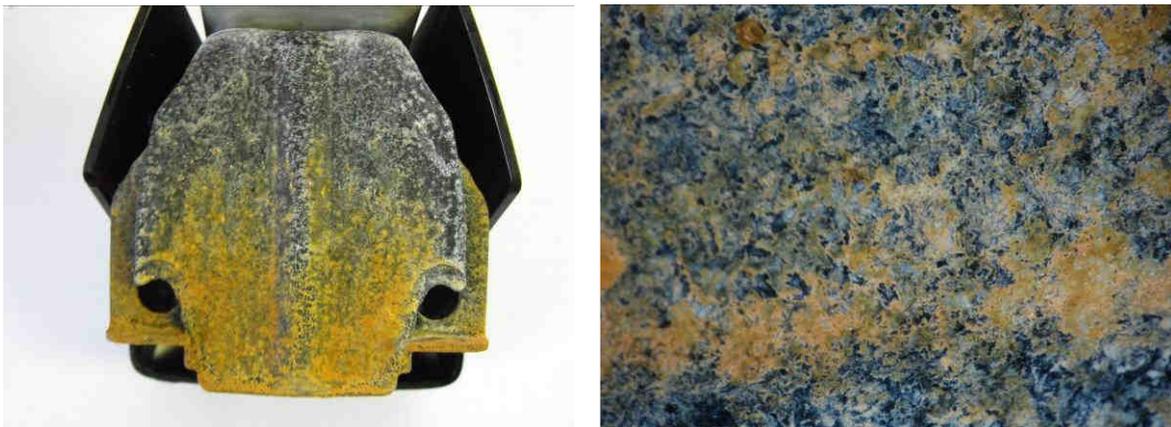
Figure 10: Component with Zn-Ni alloy coating corrosion attack after 3 cycles in test with SO₂ (2 L dosage)
