Testing of conservation means for steam engines as a part of industrial cultural heritage

*Katerina Kreislova, Alena Koukalova, SVÚOM Ltd., Prague/Czech Republic;
Antonin Svec, Mining Museum, Pribram/Czech Republic; Alexandr Zaspal, Coal Mine
Michal, Ostrava/Czech Republic; Jaroslav Vysin, Sladeckovo vlastivedne muzeum v
Kladne, Kladno/Czech Republic*

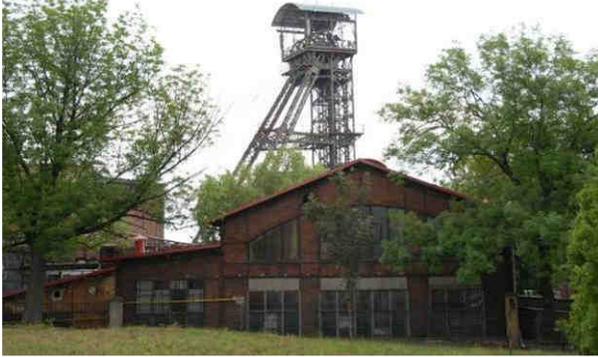
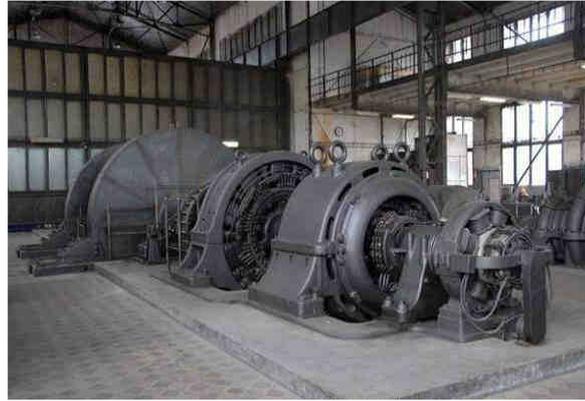
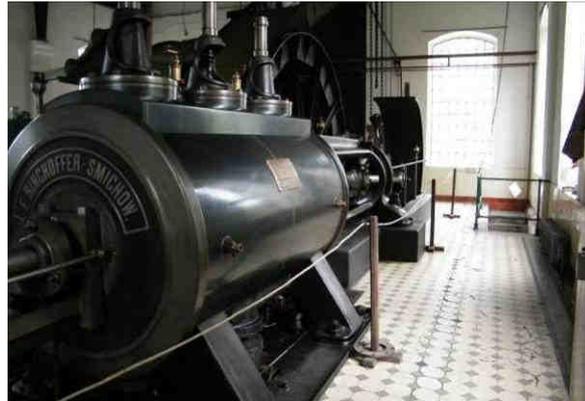
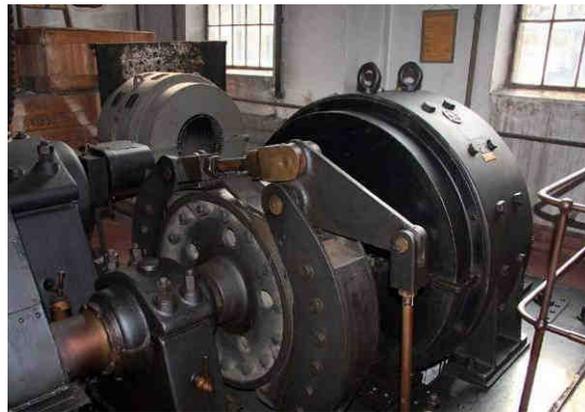
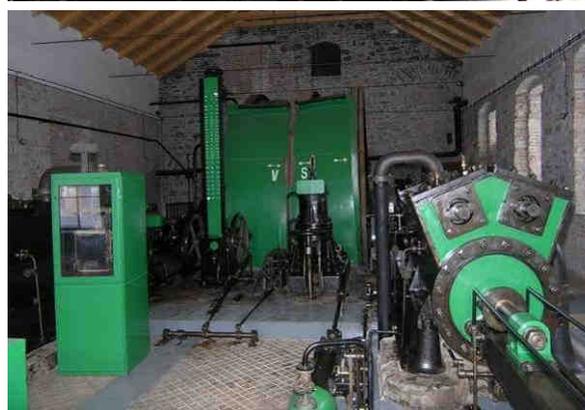
Ostrava, shaft Michal, engine house

Vinarice, shaft Mayrau, engine house

Vinarice, shaft Robert, engine house

Pribram, shaft Vojtech, engine house

Figure 1: Mining museum engine buildings and equipments

As a result of the industrial revolution and rapid economic progress over the 19th and 20th centuries, Europe has a rich industrial culture heritage which represent many different sites such as mines and steel works, the energy sector - power stations, warehouses, mining equipment and machinery, geometers, the chemical industry, water-supply and the transport systems made by metallic materials. Integral parts of industrial heritage are various machines and other equipments such as communication, laboratory, measuring tools, etc.. These machines and equipments are usually exhibit in non-heated, not air-conditioned spaces (industrial historical buildings) – Figure 1.

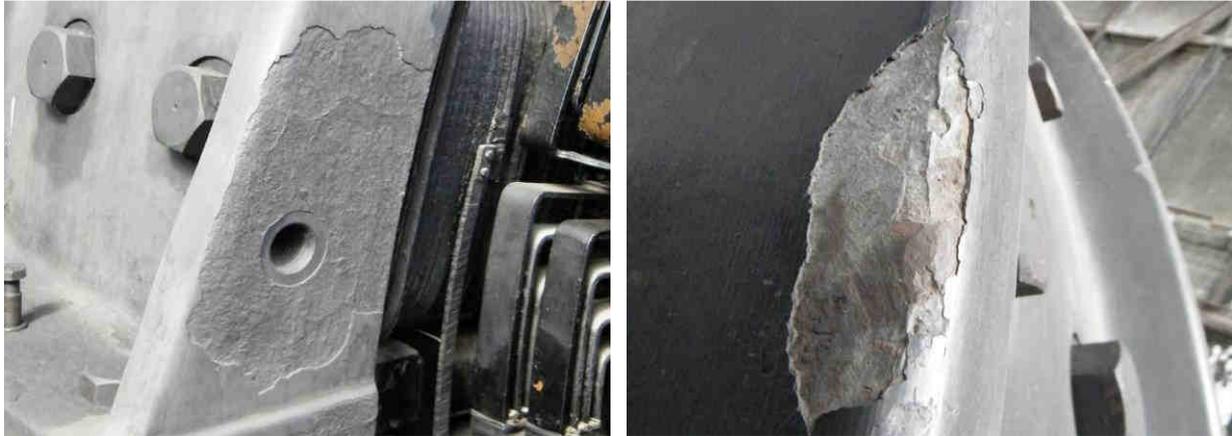
The majority of machine frames are made by cast iron which has good resistance to corrosion due to the microstructure component compounds – graphite and phosphite eutectic - and the tough surface skin formed as the castings cooled. Cast iron corrosion tends to flake and crumble - this phenomenon is evident on machine frames (Fig. 2).

Figure 2: Example of cast iron flaking on machine frames

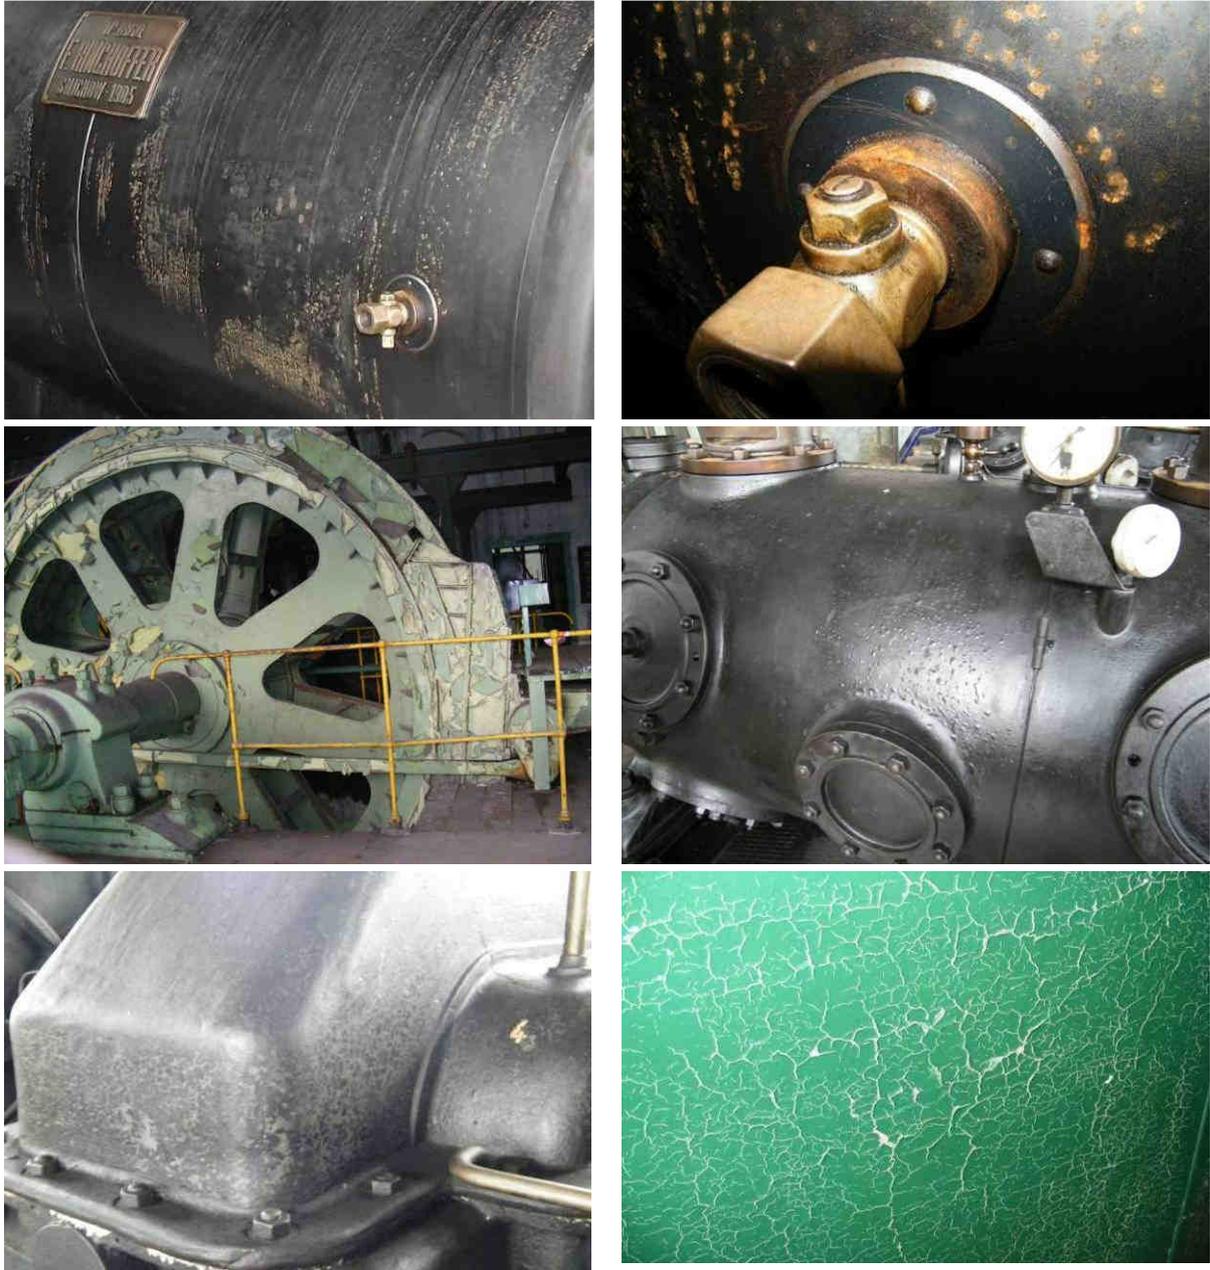
The machines are usually exposed for 50 to 100 years, but for the majority of this exposure the surface was protected by different paints. The coating layer thickness of machines is very different on each part – they vary from 50 µm to 1000 µm with average value ca 400 µm. There were found similar failures of paint layers – rusting, cracking, flaking and peeling off (Fig. 3).

Figure 3: Deterioration of paint system on machines

As the indoor environments of non air-conditioned engine houses have high relative humidity, the very specific damage was found – blistering (Fig. 3e). Many engine houses have large windows so in the summer season the side of machines' surface oriented to the south is exposed to high temperature and degradation. On these surfaces the paint deterioration in the form of mud cracking was found (Fig. 3f). All forms of paint failure lead to corrosion attack of iron/steel substrate.

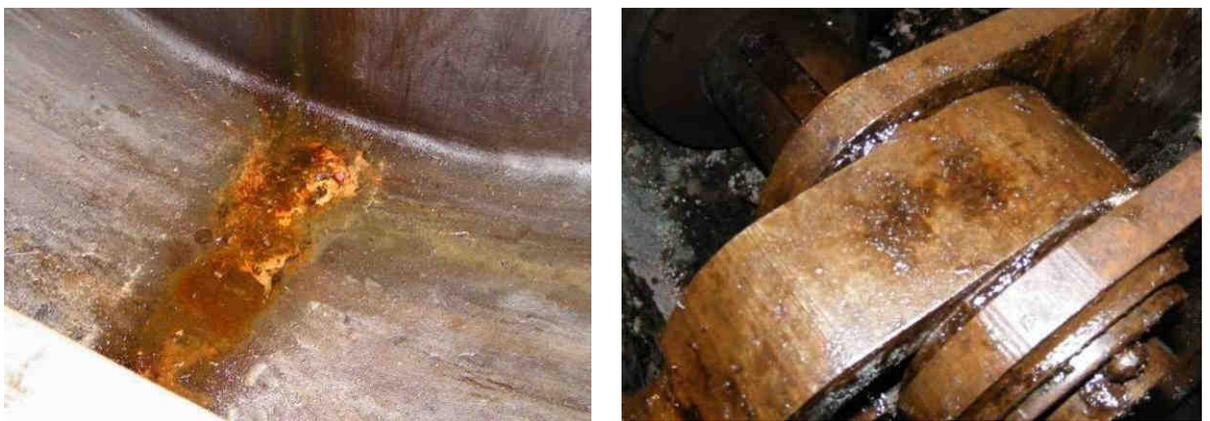
The thick residual layers of greases and oils should give a barrier protection but on the other hand they increased the corrosion attack of materials (Fig. 4), because during degradation their acidity increased and they also absorbed some air moisture. These films may also cumulate solid particles with different chemical properties (e.g. carbon particles) which may increase the corrosion damage.

Figure 4: Examples of residual oils and greases on steam engine parts

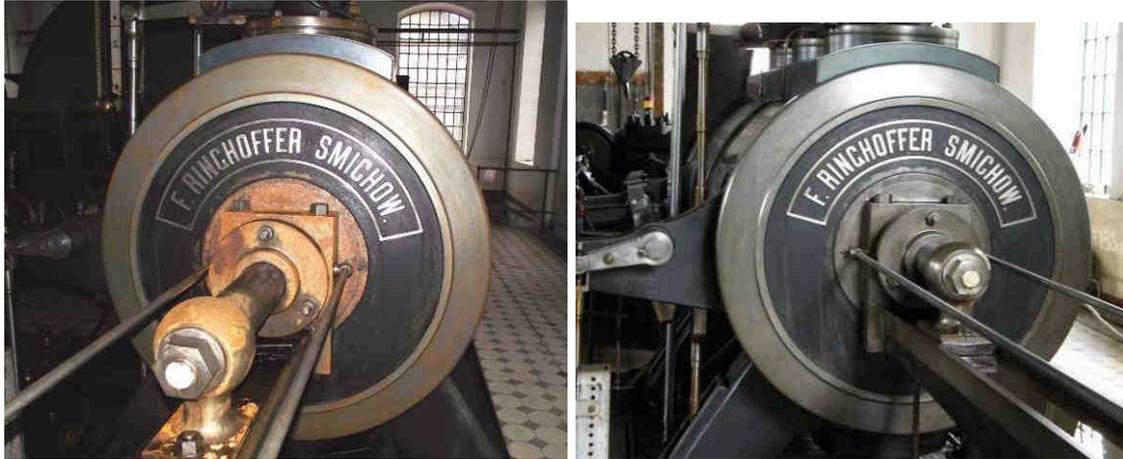
Figure 5: Example of steam engine before and after conservation (1 year left without regular maintenance)
